Re: Results of Hecla and OMG Site Visit  
of May 16 -17, 2005

**SUBJECT:** Technical Memorandum for the Site Visit to the Hecla Impoundment (Pond #2) and Inspection of the Supplemental Environmental Project at the OMG Facility, St. George, Utah

**FROM:** Randall W. Breeden, Geohydrologist  
RCRA Corrective Action Technical Support

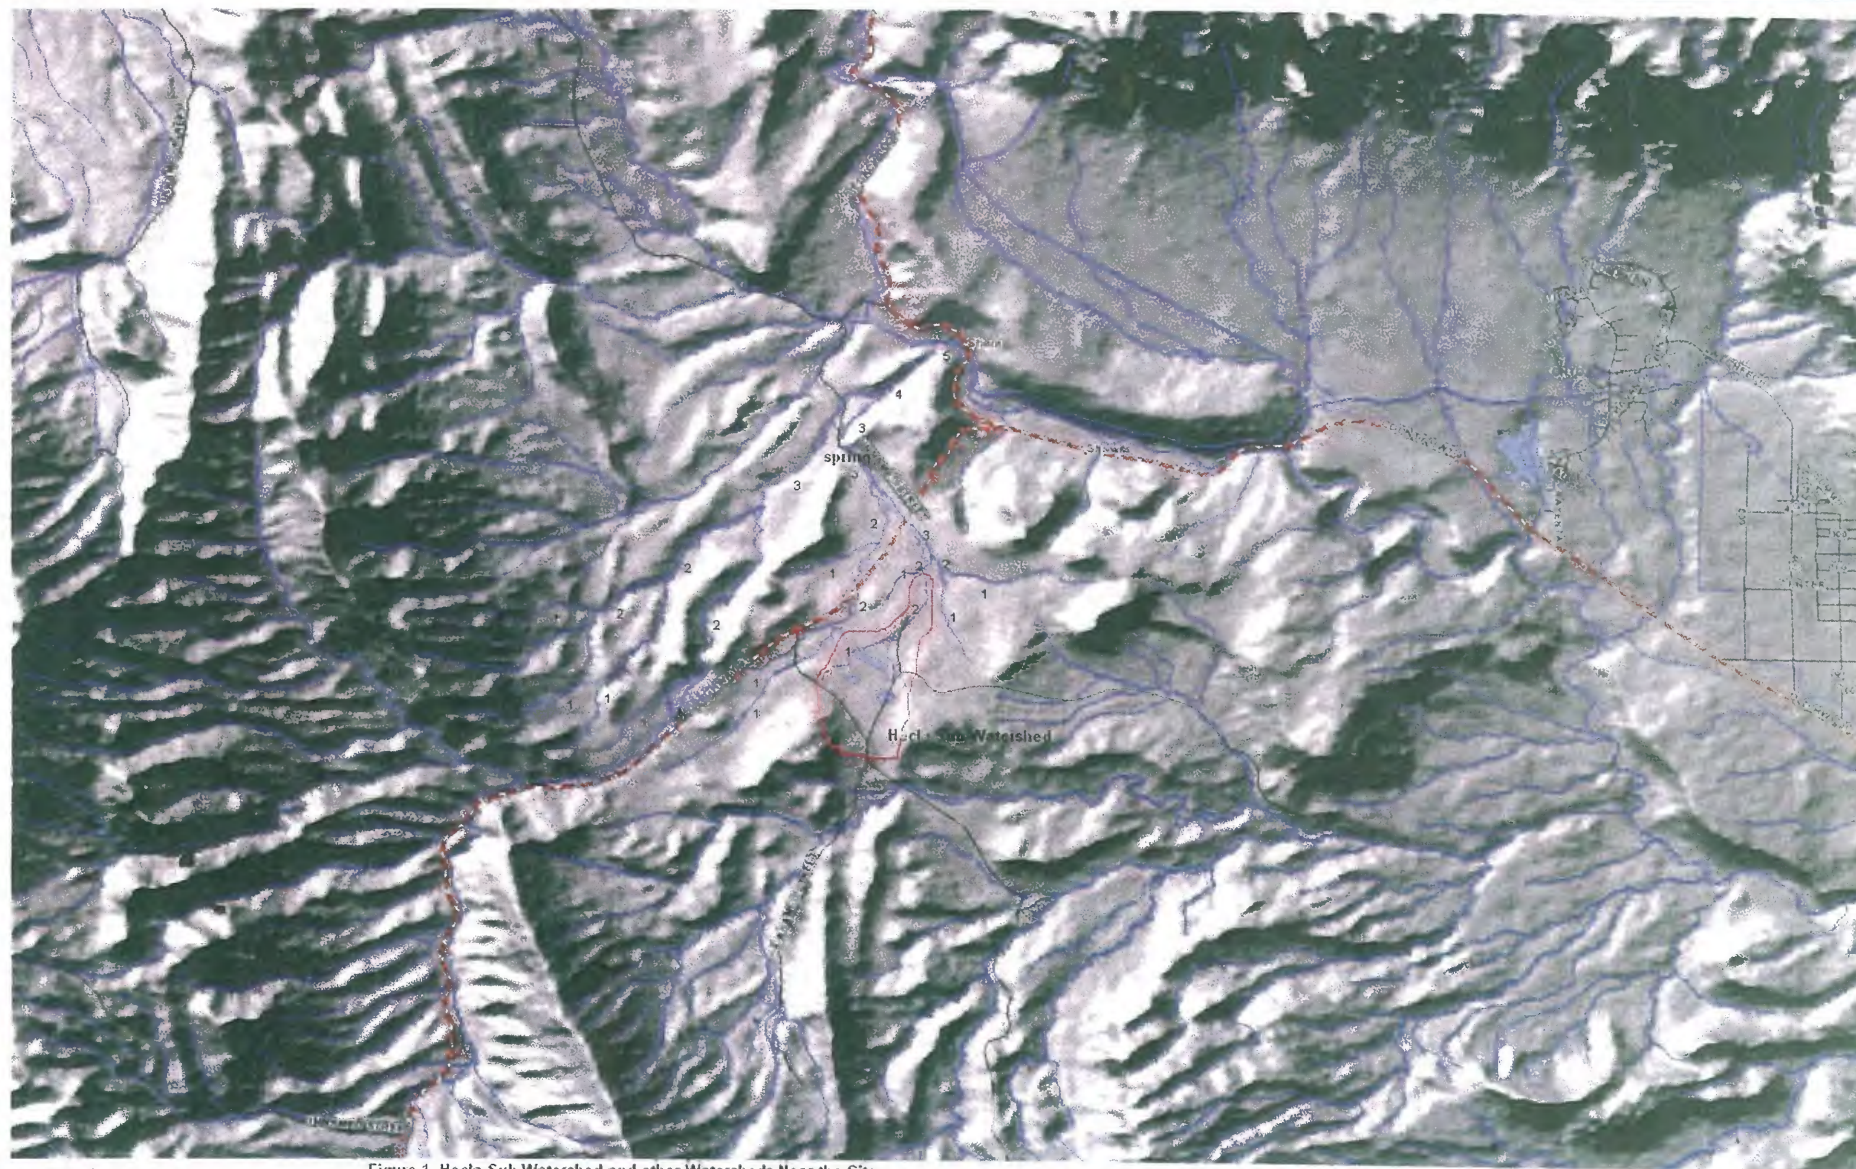
Figure 1. Hecla Sub-Watershed and other Watersheds Near the Site

distance from the impoundment to the river is approximately 2 miles. Figure 1 shows the sub-watershed containing the Hecla site and surrounding surface water drainage for the Santa Clara River in the vicinity of the Hecla site. The entire 1<sup>st</sup> order reach and approximately 75% of the linear distance of the 2<sup>nd</sup> order reach are ephemeral. Geologic structure located approximately 0.6 miles above the Santa Clara River forces ground water to discharge to the surface, thus creating a well defined spring, see Figure 1 and pictures 14, 15, 16 and 17. An estimation of the surface flow, at the time of observation, was approximately 0.1 cfs or less. This flow continues, with no observable increase in ground water discharge all the way to the Santa Clara River and was the only observed flowing water along the entire length of the 2<sup>nd</sup> – 4<sup>th</sup> order reaches. No other ground water discharge, or surface water input was observed between the Hecla site and Santa Clara River.

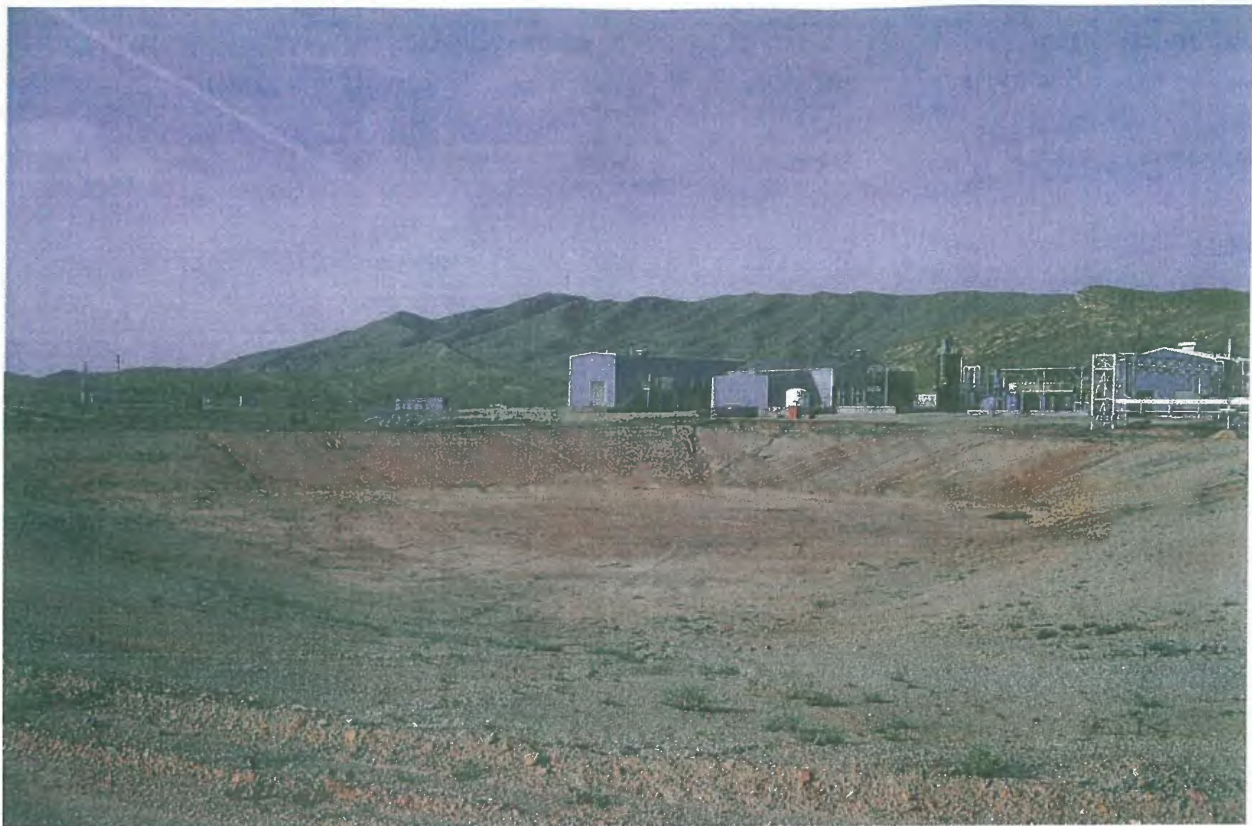
Requirements of the SEP at the OMG facility include removal of all liquids, sediments, liners, and contaminated soil beneath the liners from three closed evaporation ponds. Visual examination of the three closed ponds indicates that the liquids, sediments, and liners have been completely removed from the ponds down to bare, visually clean soil. This site visit did not include the collection and analysis of soil samples from the former ponds. Therefore, determination of whether contaminant concentrations within the former ponds are at or below the

required clean up criteria was not confirmed by this visit. However, if prior analytical results indicate that contaminant concentrations are at or below the clean up criteria stipulated in the January 30, 2004 Sampling and Analysis Plan, then closure of these ponds should be considered complete. Pictures 1, 2, 3, and 4, show the current condition of the three former evaporation ponds.

Picture 1. OMG Closed Evaporation Pond

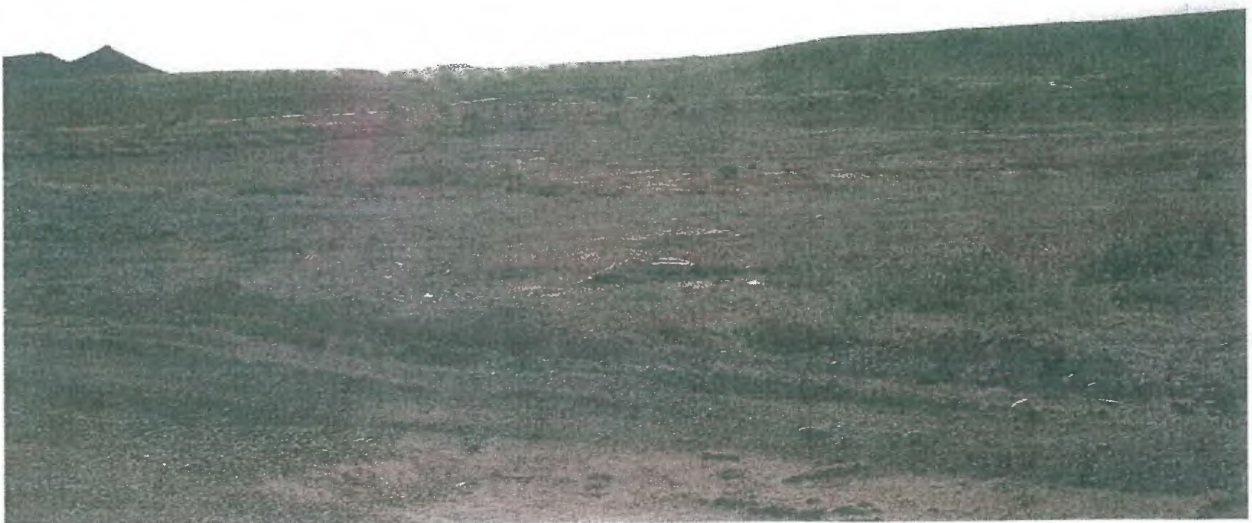
Picture 2. OMG Closed Evaporation Pond

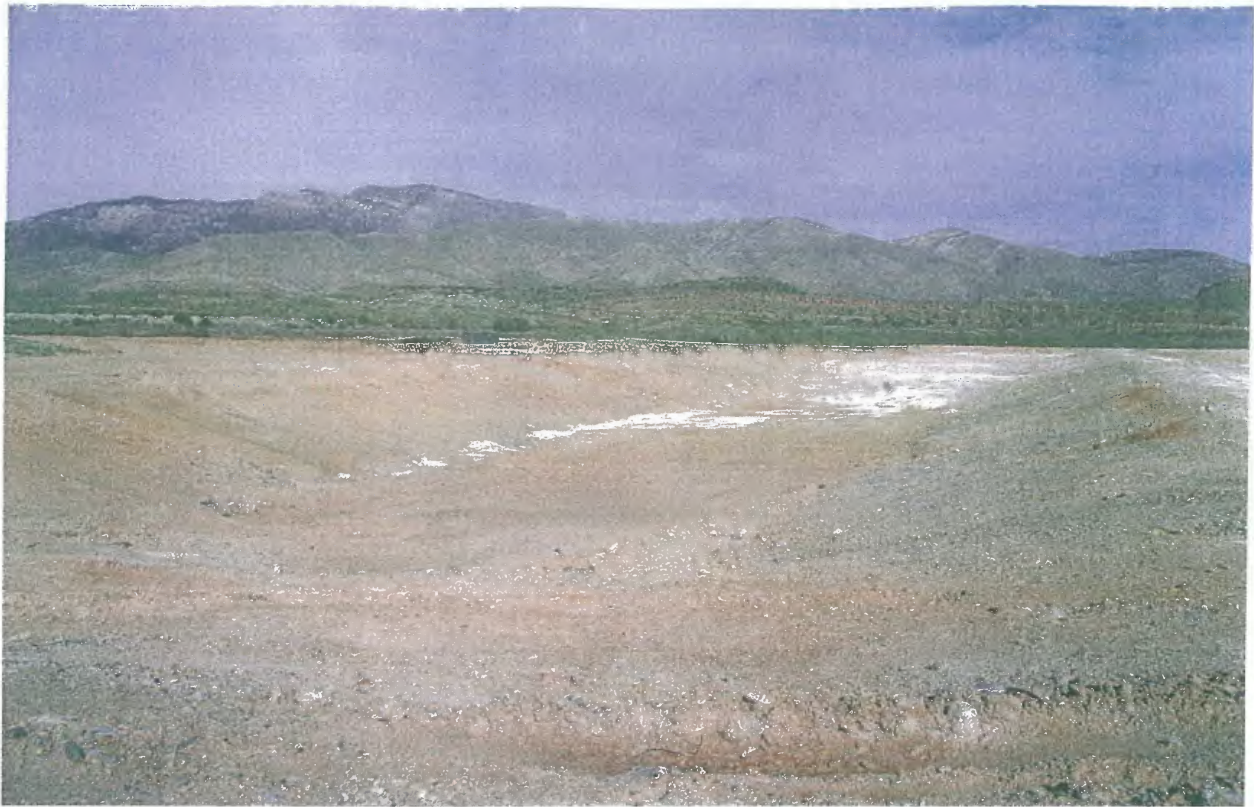
Picture 3. OMG Closed Evaporation Pond

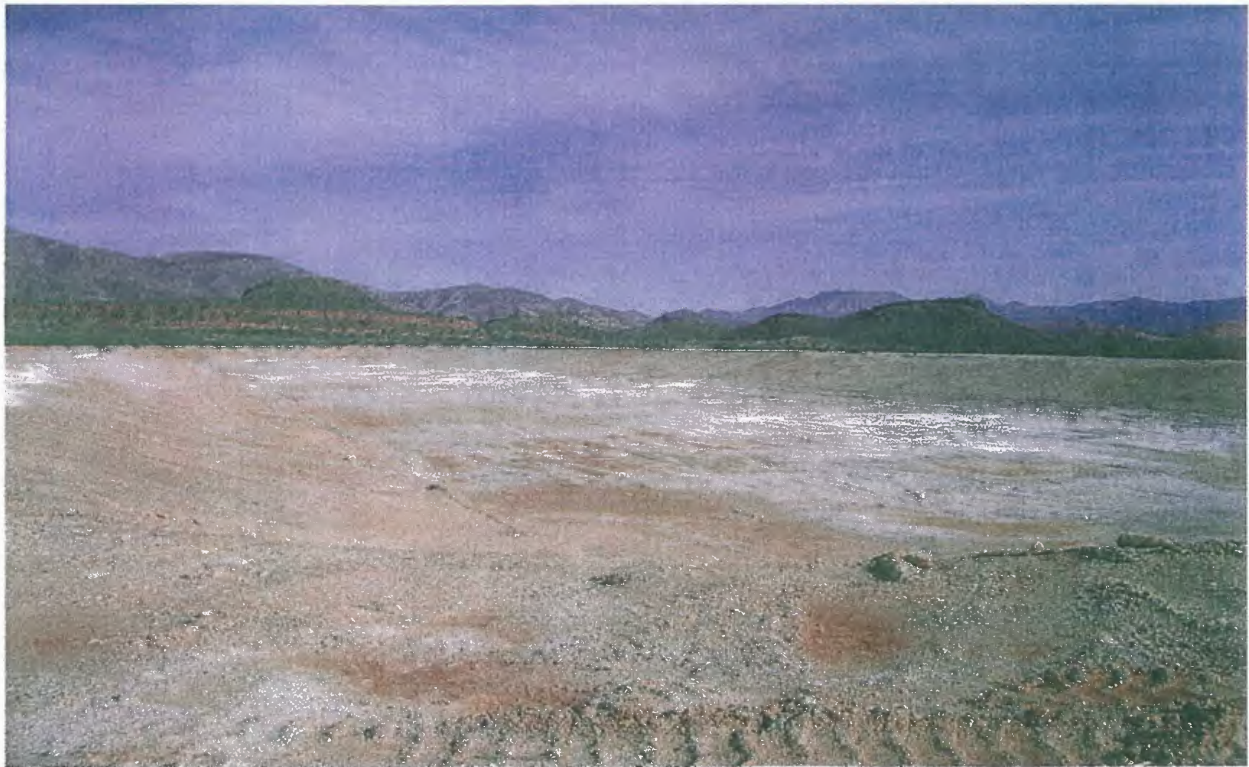
Picture 4. OMG Closed Evaporation Pond

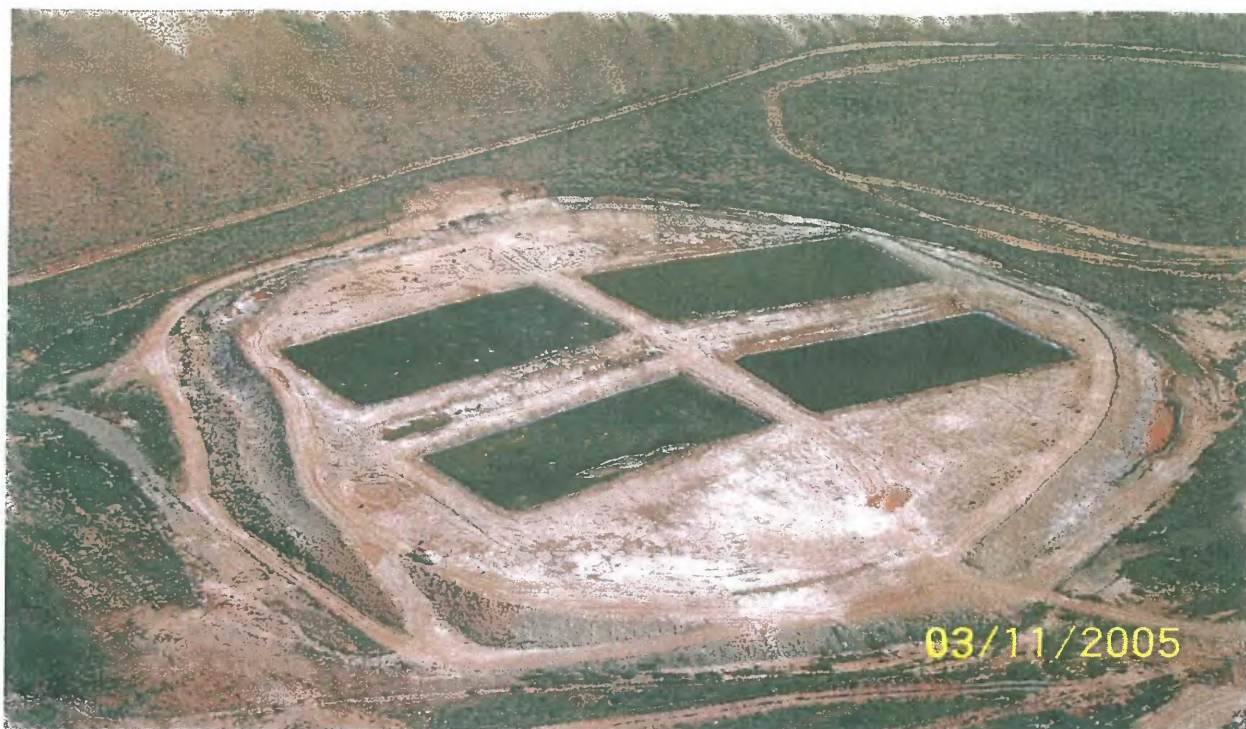
Significant progress has been made regarding the installation and operation of the dewatering project for the impoundment. To date, four HDPE lined evaporation ponds, each of which is approximately one half acre in surface area and three feet deep, have been installed on top of the impoundment. The ponds gather and evaporate liquids collected from 17 shallow sumps and 7 deep sumps installed within the pond. The objective of the dewatering project is to remove all free liquids to a minimum of two feet below the top of the original liner. Liquid level in the sumps are monitored daily and if liquid is present, it is pumped out of the sump(s) into one of the evaporation ponds. In addition, liquids that accumulate in the lined impoundments along the seeps on the outside of the impoundment are also pumped into the evaporation ponds. The collection and evaporation of free liquids from within the impoundment will continue until the level of liquid is two feet below the top of the original liner. The exact length of time needed to attain that goal is dependent on several factors, primarily evaporation rates and precipitation amounts. However it is expected to continue throughout the summer. The liquid level in the evaporation ponds is dependent upon how much is liquid enters the sumps. Operations to date indicate that the liquid level in the evaporation ponds can be maintained at approximately one foot in depth, leaving two feet of free board in each evaporation pond. Pictures 5, 6, 7, 8, and 9 show the evaporation ponds.

Picture 5. Aerial View of the Four Evaporation Ponds

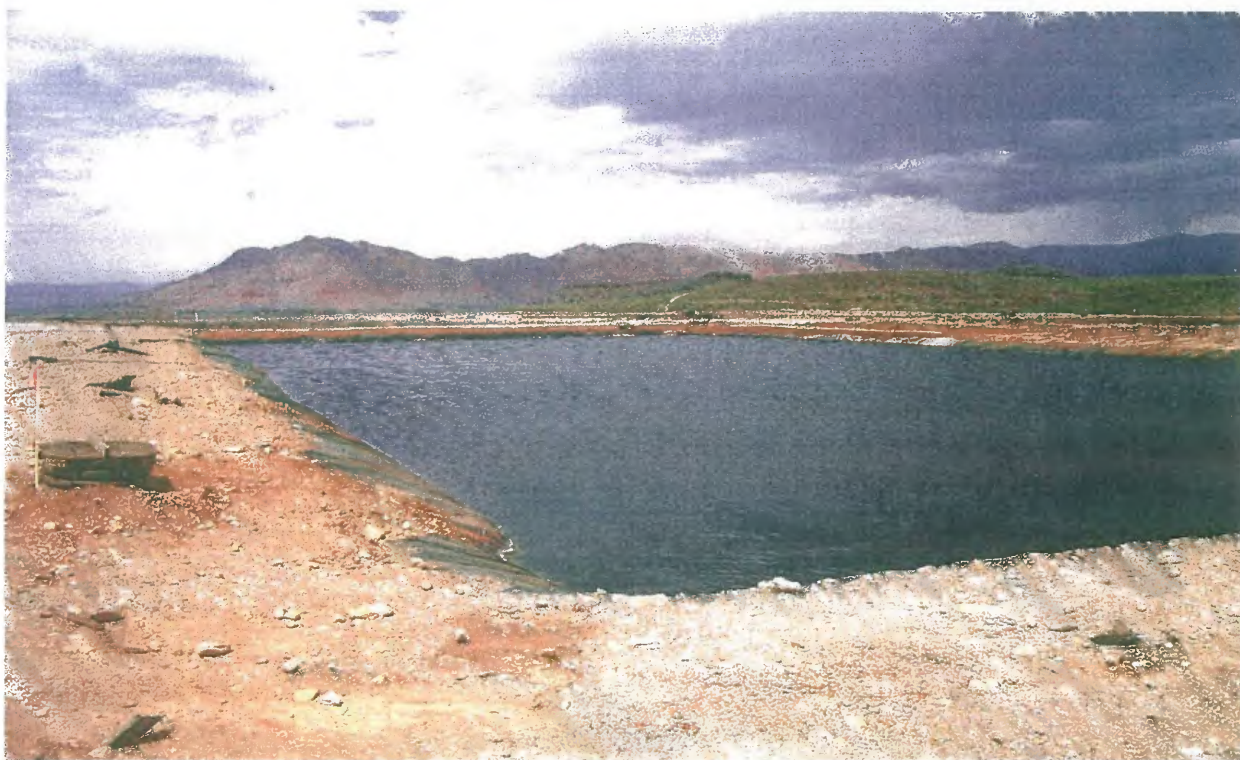
Picture 6. Evaporation Pond

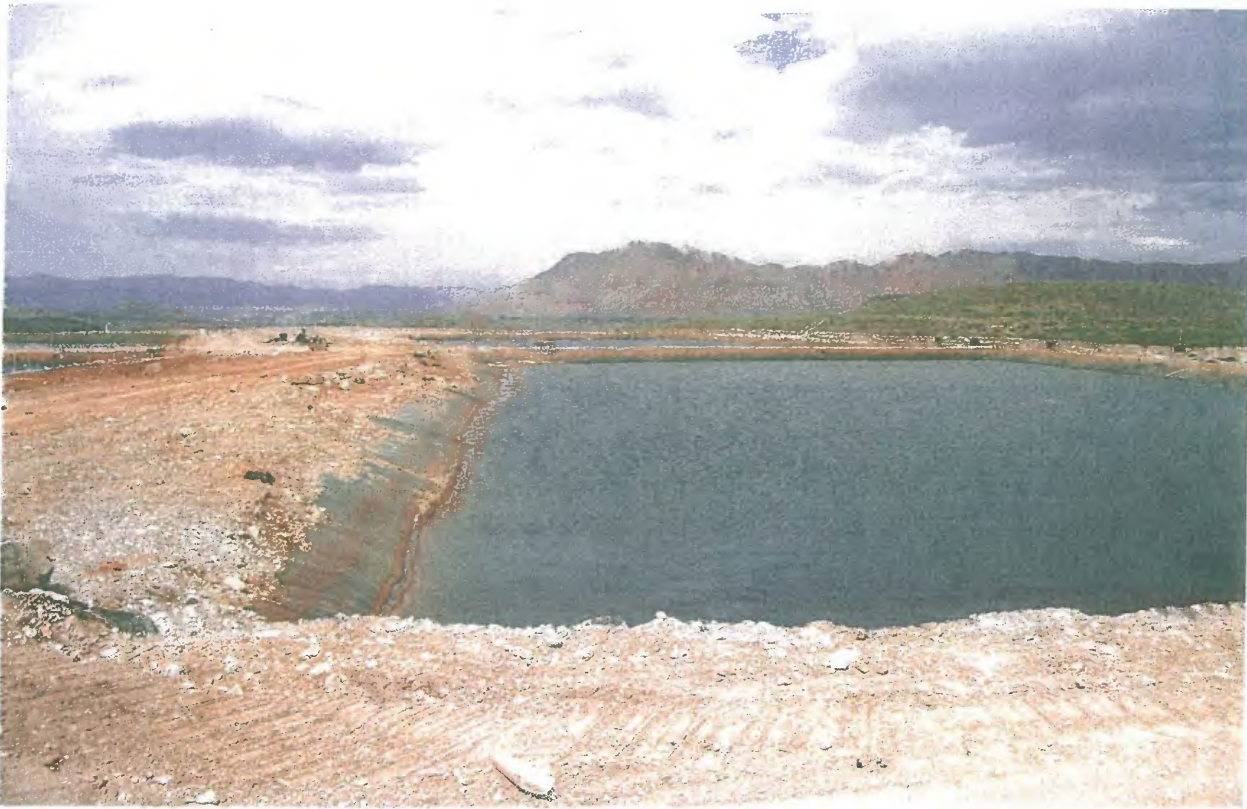
Picture 7. Evaporation Pond

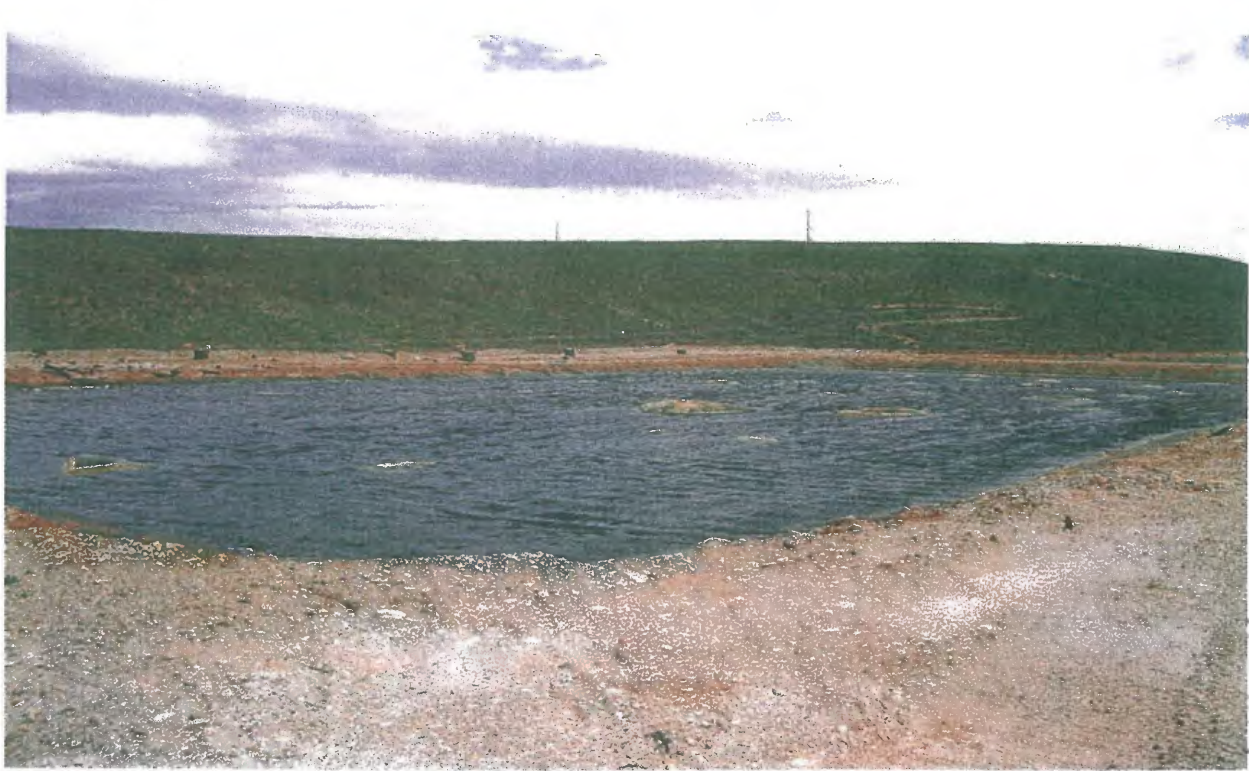
Picture 8. Evaporation Pond

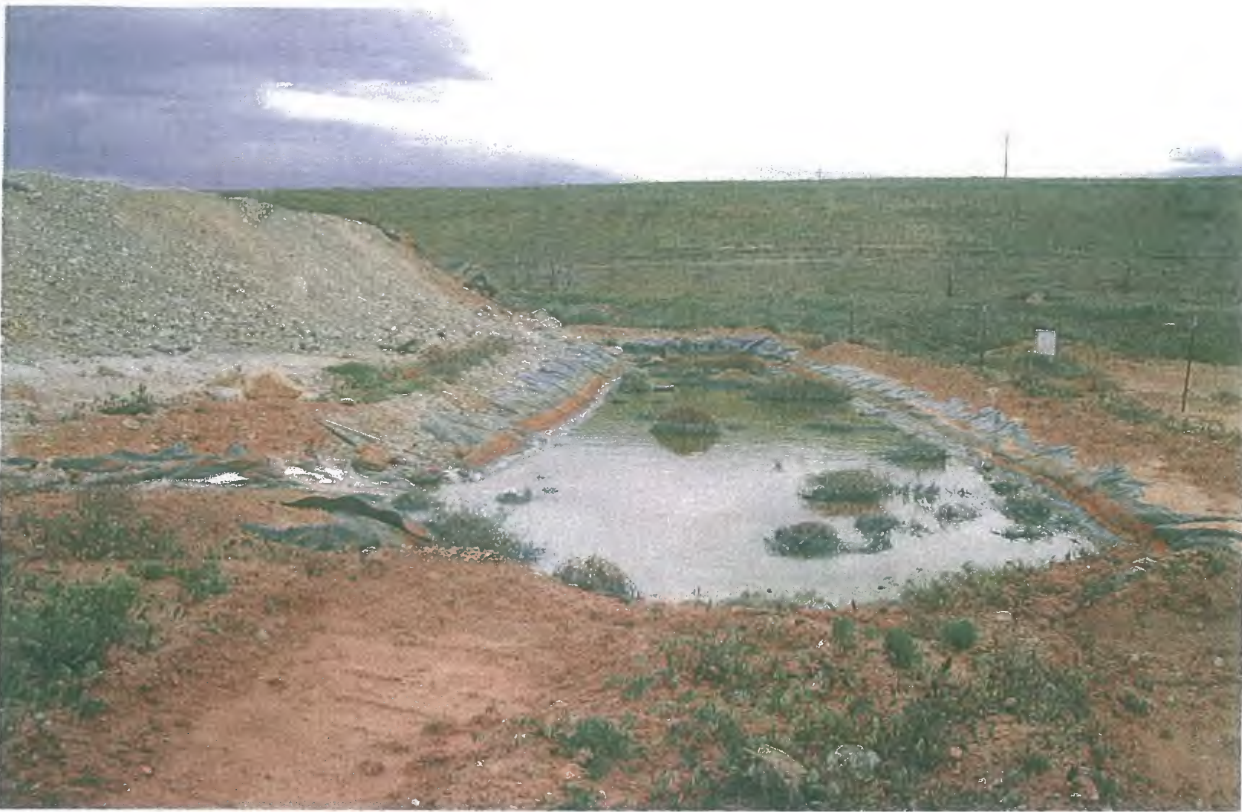
Picture 9. Collection and Evaporation Pond for the Southwest Seep Area

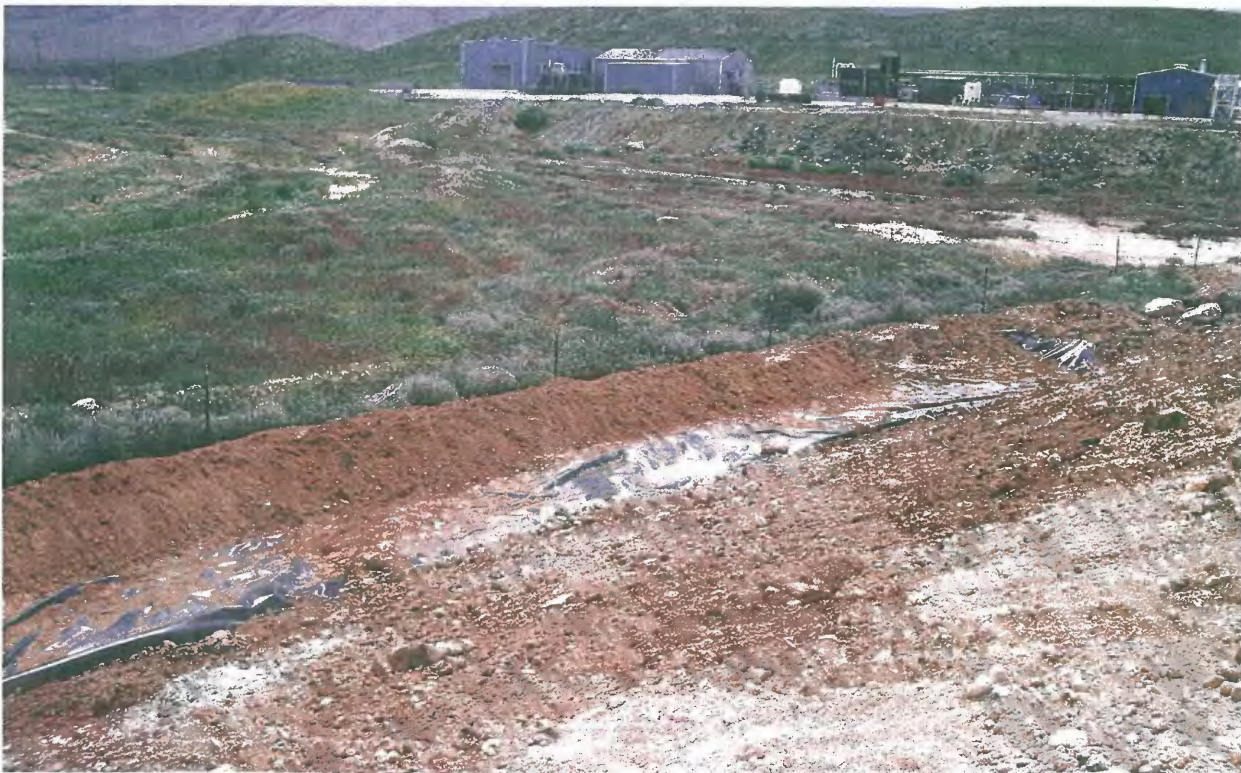
At the present, and until the final grading begins, a temporary HDPE liner has been installed around the toe of the outside perimeter of the impoundment, see pictures 10 and 11. This liner is to prevent erosion of the toe of the slope in the event of a high precipitation event. It will be removed when final grading and armoring of the run-off channel is constructed.

Picture 10. Temporary Run-On, Run-Off HDPE Liner

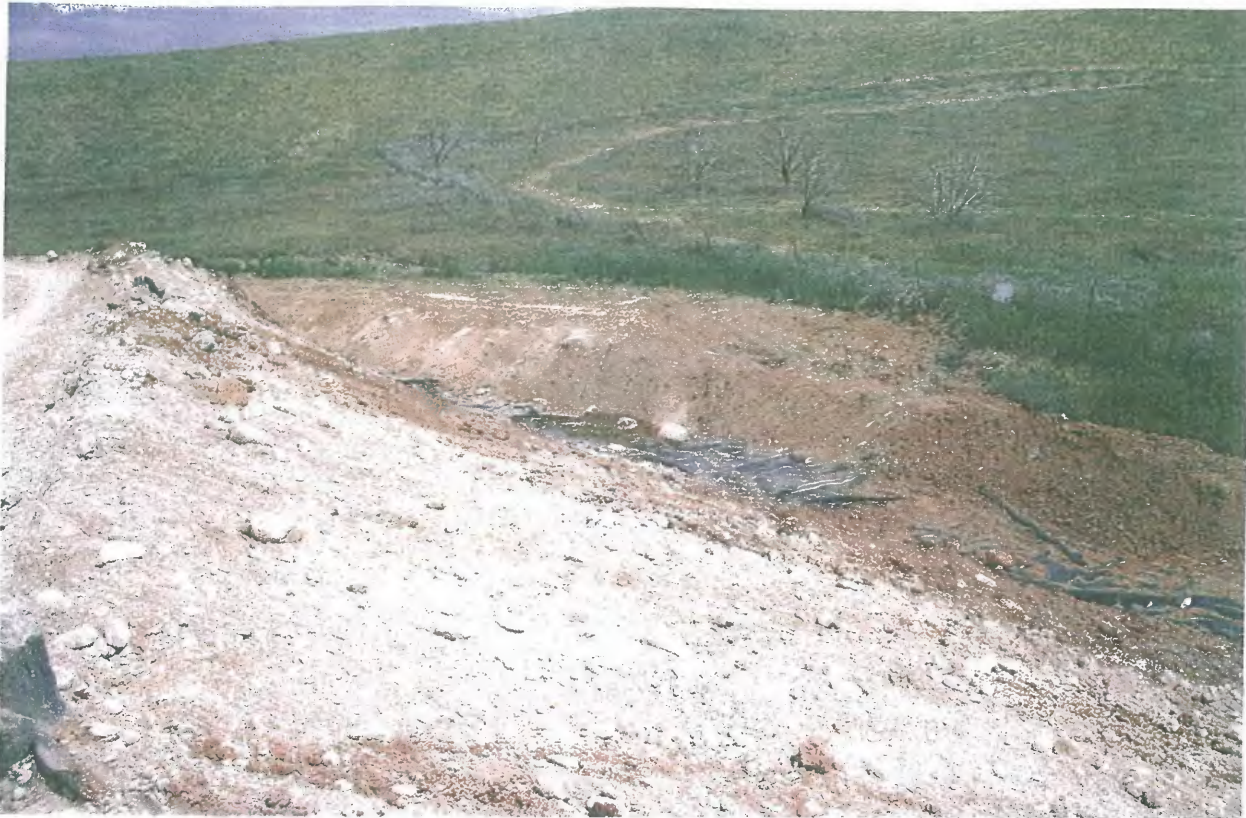
Picture 11. Temporary Run-On, Run-Off HDPE Liner

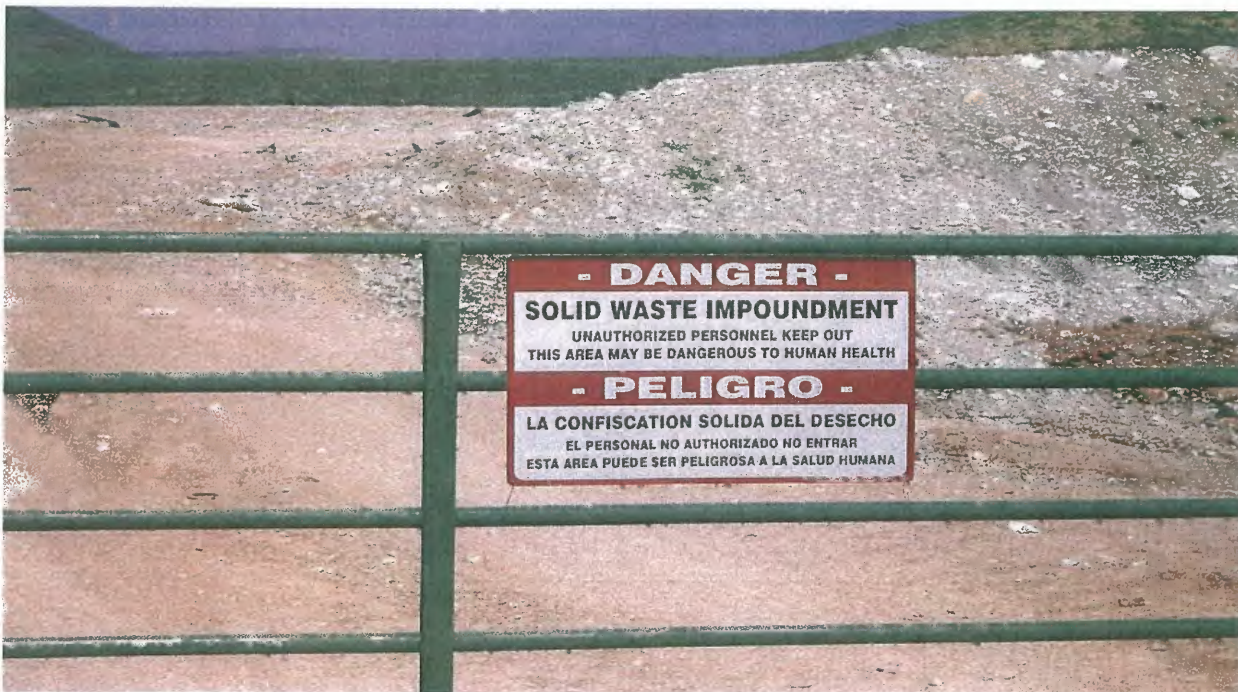
The site is completely fenced and has warning signs placed every 100 ft. as well as on the entrance gate. See pictures 12 and 13.

Picture 12. Warning Sign On the Gate

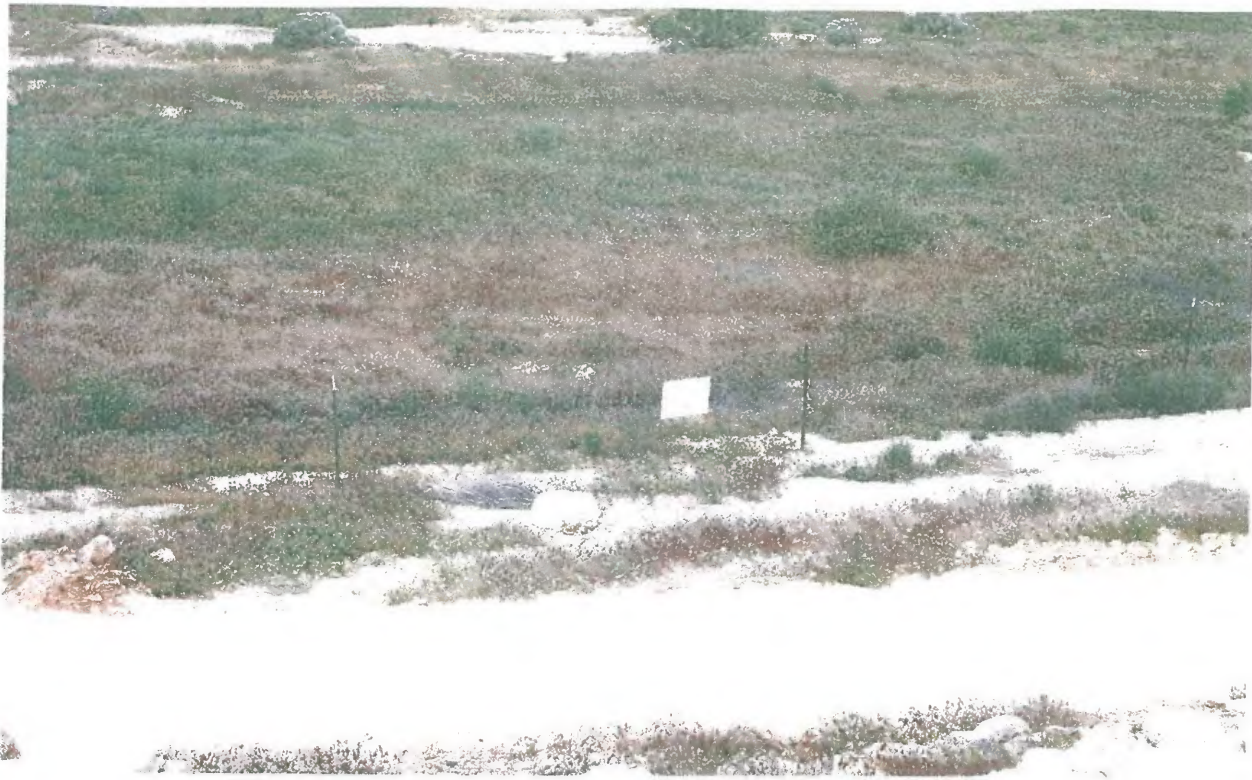
Picture 13. Fencing and Warning Sign Around Impoundment.

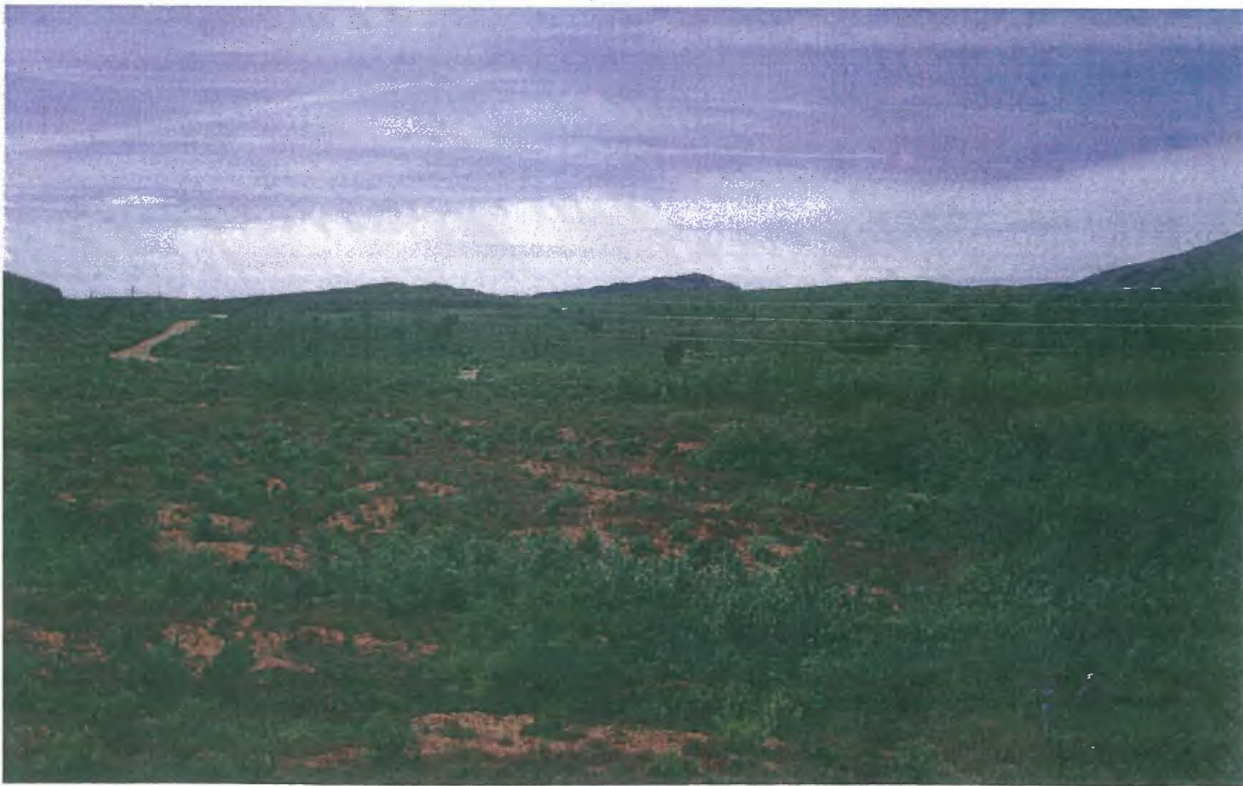
Picture 14. Spring Area, the Lush Vegetated Area is Where the Ground Water Begins to Discharge, Note No Vegetation on Other Side of Road

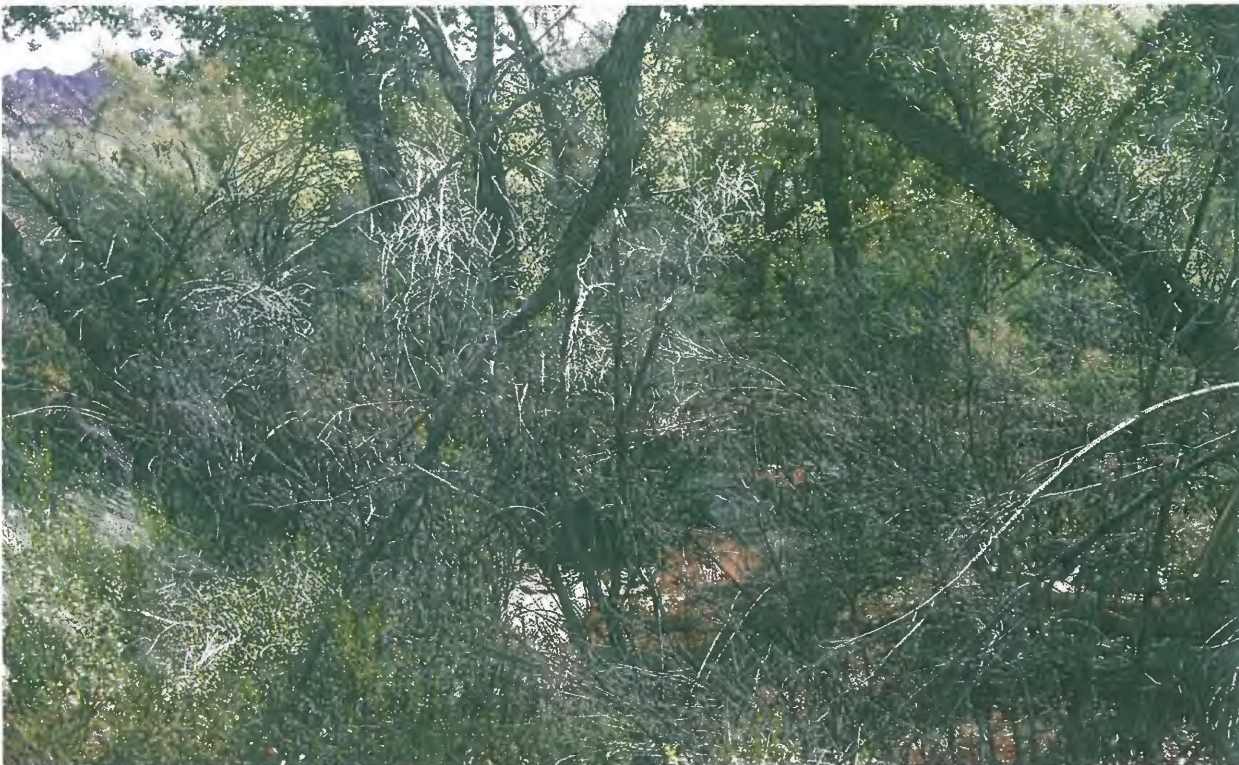
Picture 16. Riparian Habitat In Spring Area and Along Stream. Note, No Evidence of Flooding or Scouring.

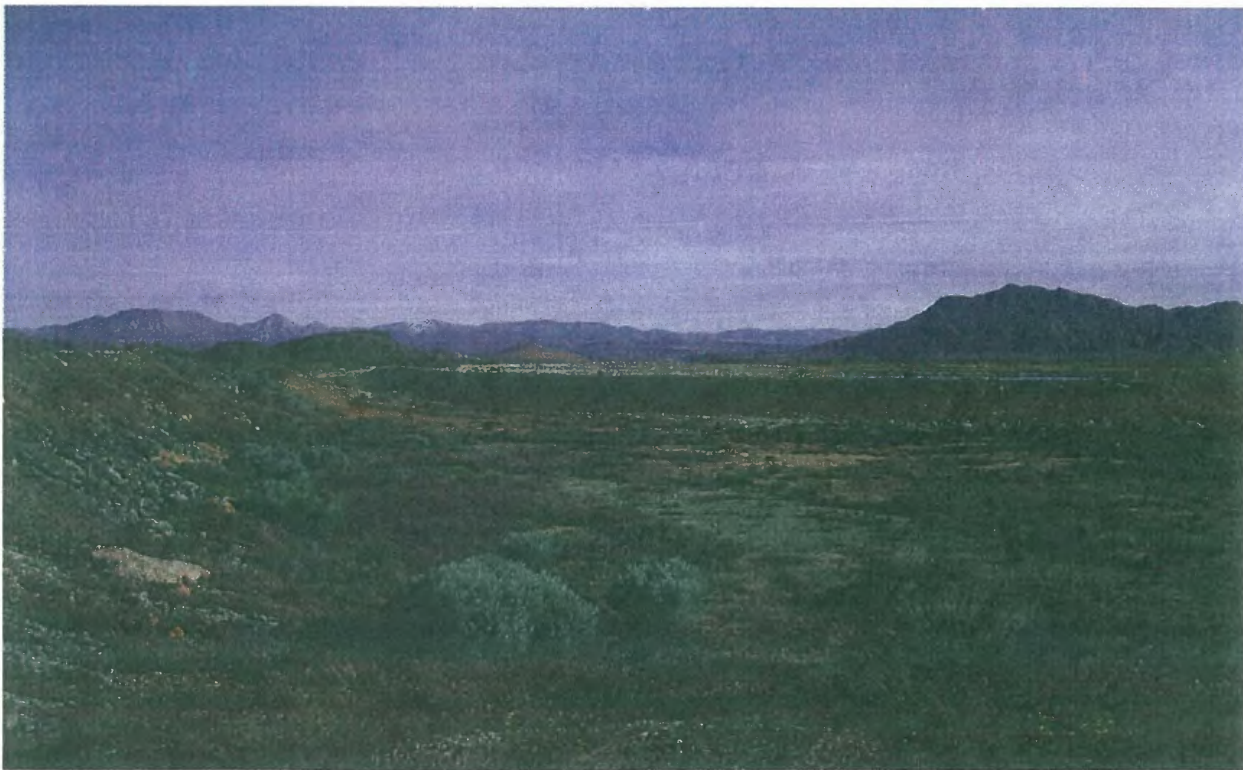
Picture 21. Drainage Around Unit, Interceptor Berm (Run-On Control) from Road Construction Within the Sub-Watershed.

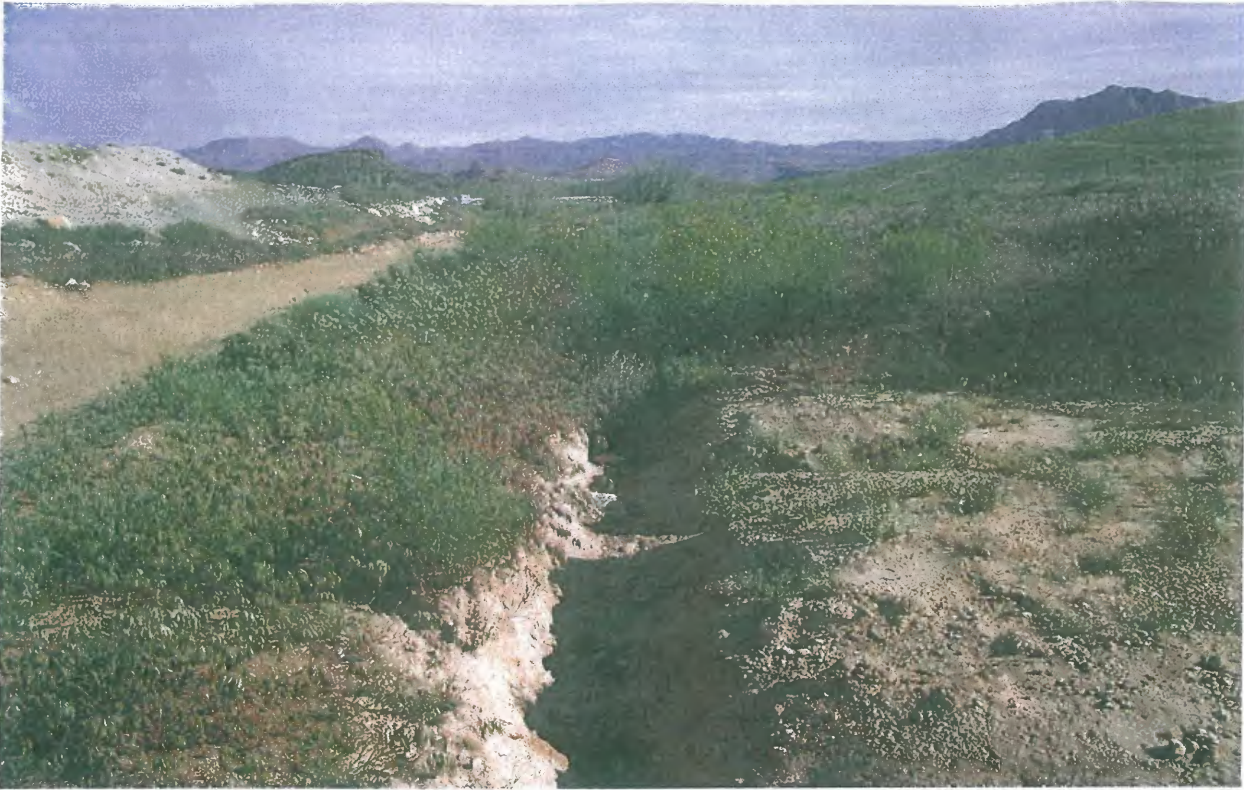
Picture 23. Incised Channel Around the Unit.

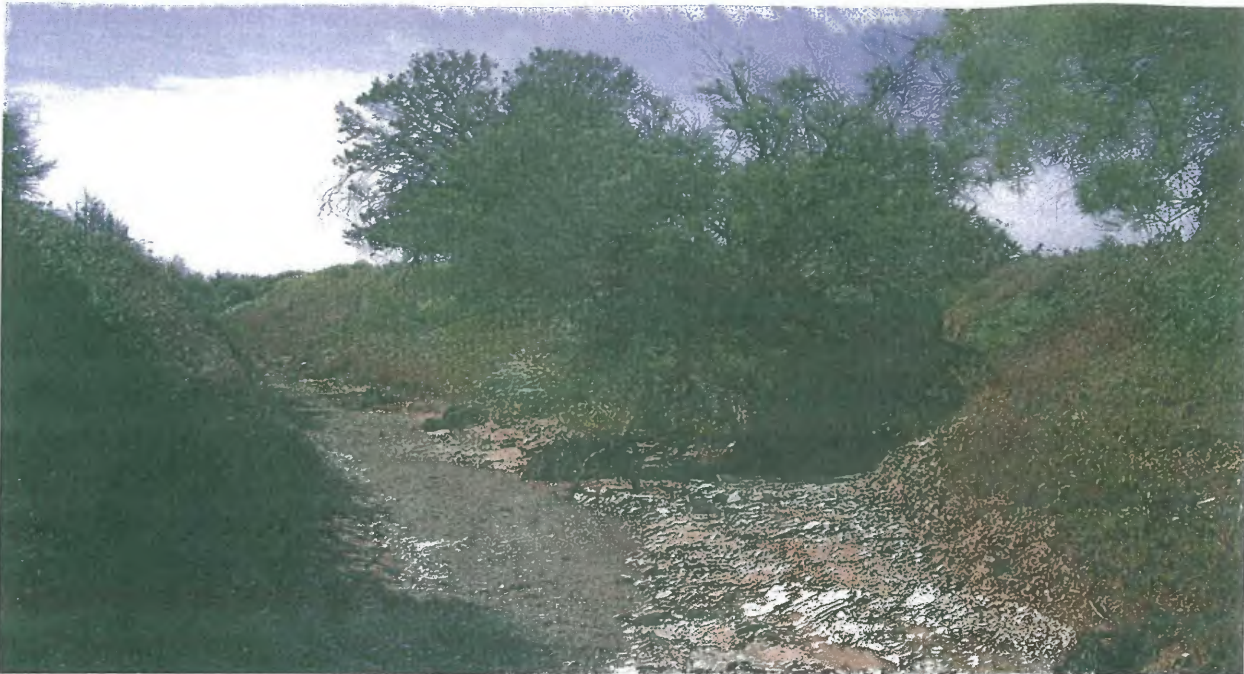
Picture 33. Confluence of the Two 2<sup>nd</sup> Order Reaches South of Old Highway 91. Drainage from the Site is to the Right of the Tree in the Streambed. The reach on the left has much greater flow than the one coming from the site.

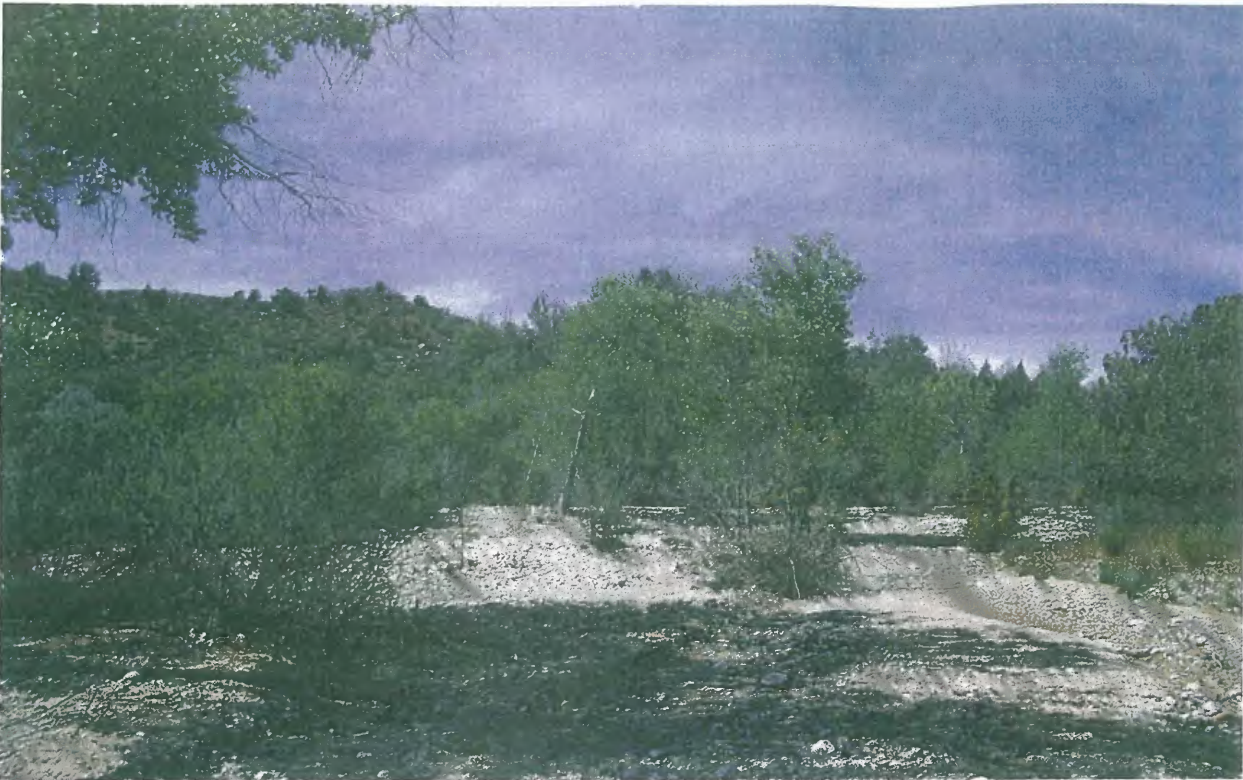
Picture 43. Confluence of 3<sup>rd</sup> Order Streams, (note the scouring from the flooding).

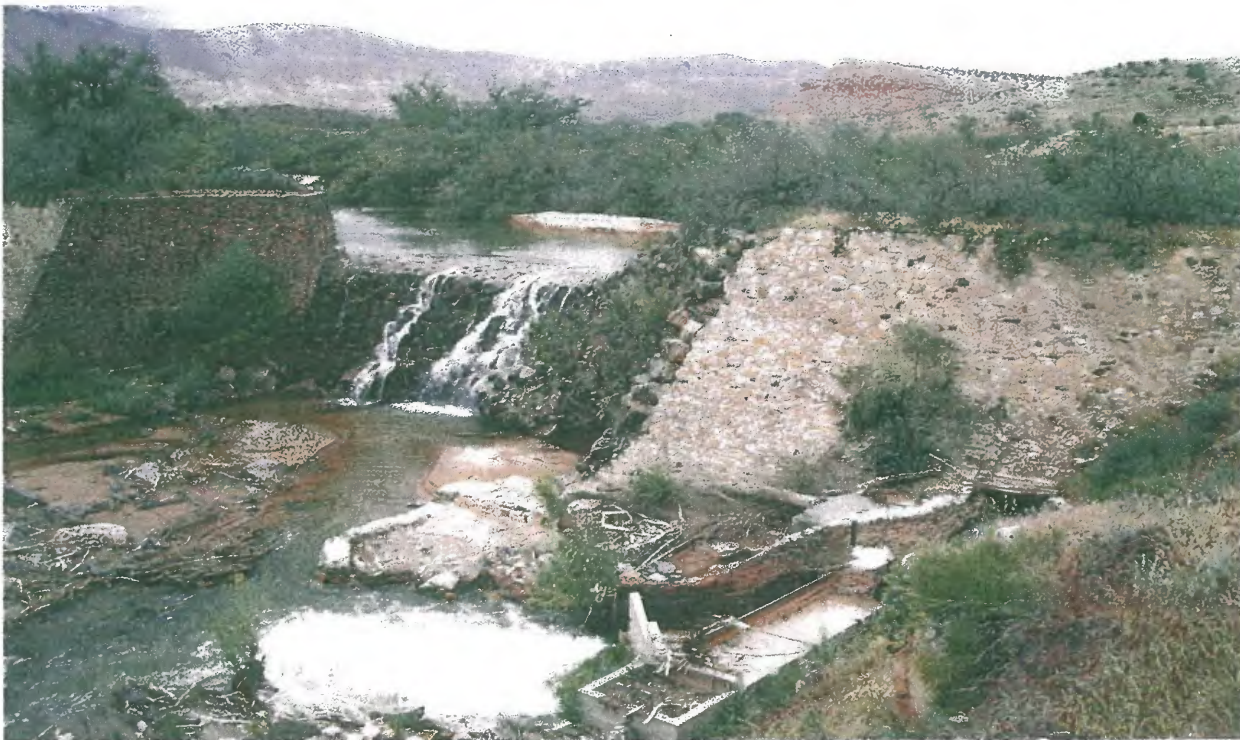
Picture 44. Shem Dam and Headgate, (note disrepair)
